UPDATE – 2011

EI-ACF FORCED LANDING, JANUARY 1, 1953, SPERNAL, ENGLAND.

REPORT ON THE ACCIDENT TO BOEING 777-236ER,

G-YMMM, AT LONDON HEATHROW AIRPORT ON

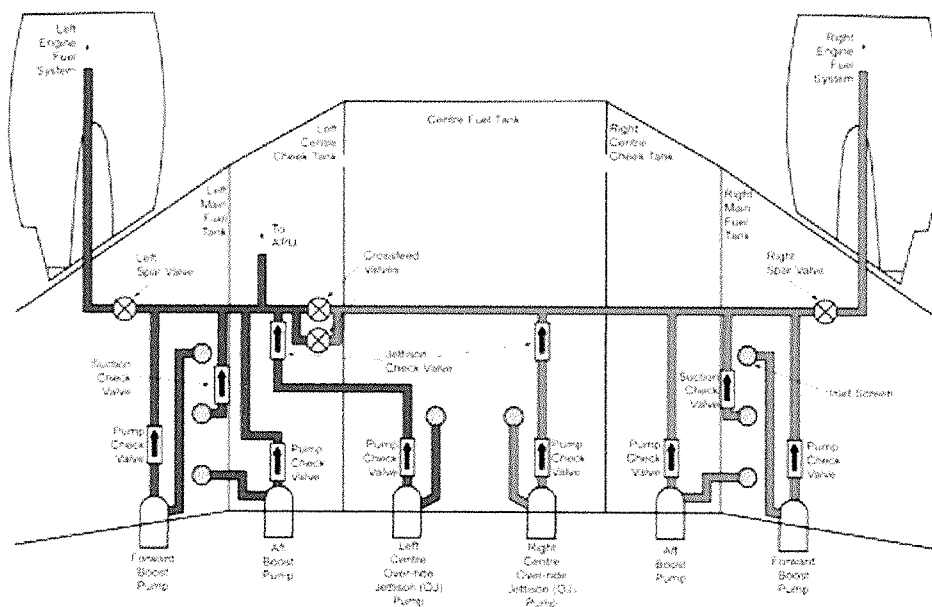
Figure 6

Simplified diagram of the airframe fuel system

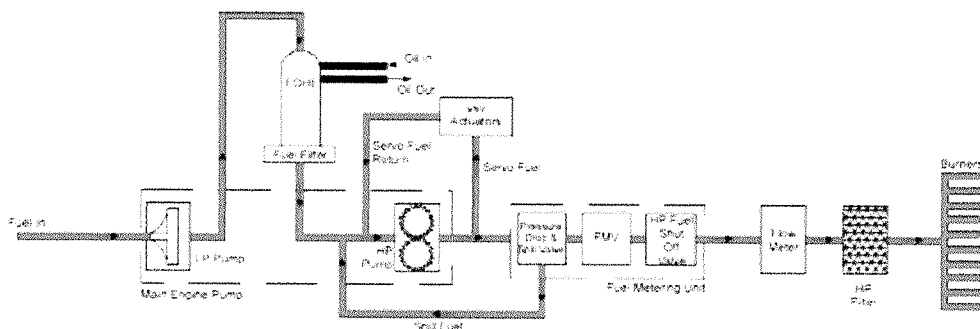
Figure 7

Simplified diagram of the engine fuel system

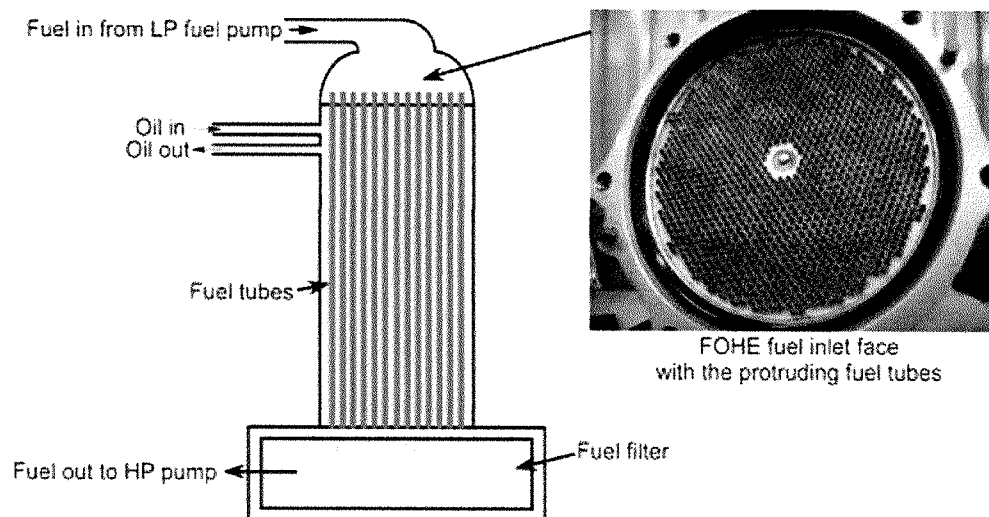
**Figure 8****Fuel Oil Heat Exchanger (FOHE)**

The FOHE serves the dual purpose of cooling the engine oil and raising the temperature of the fuel so that ice does not affect the downstream components, including the LP filter and the Fuel Metering Unit (FMU). The FOHE is a hybrid cross-flow / counter-flow design and it includes a matrix of fine tubes. The fuel enters the top of the FOHE and passes through the tubes; the hot oil enters the FOHE main body and passes around the fuel tubes.

The temperature of the fuel after it has passed through the FOHE is considerably above its entry temperature. The FOHE matrix consists of over 1,000 small tubes that are crimped at various locations along their length to improve thermal transfer efficiency. The crimps at the inlet of the tubes are to a slightly smaller diameter than the remainder of the crimps to prevent small debris becoming lodged in the matrix. The tubes protrude by approximately 4 mm from the matrix top plate, which separates the fuel from the oil, and therefore extend into the fuel in the inlet chamber.

96. Reducing the fuel flow to idle always cleared any ice restriction on the face of the FOHE and therefore restored full fuel flow capability.
97. The FOHE was the only component in the fuel system that could be demonstrated to collect sufficient ice to cause the fuel restrictions observed during the accident flight.

- 4.5 Safety Recommendation 2009-028:** It is recommended that Boeing and Rolls-Royce jointly review the aircraft and engine fuel system design for the Boeing 777, powered by Rolls-Royce Trent 800 engines, to develop changes which prevent ice from causing a restriction to the fuel flow at the fuel oil heat exchanger.

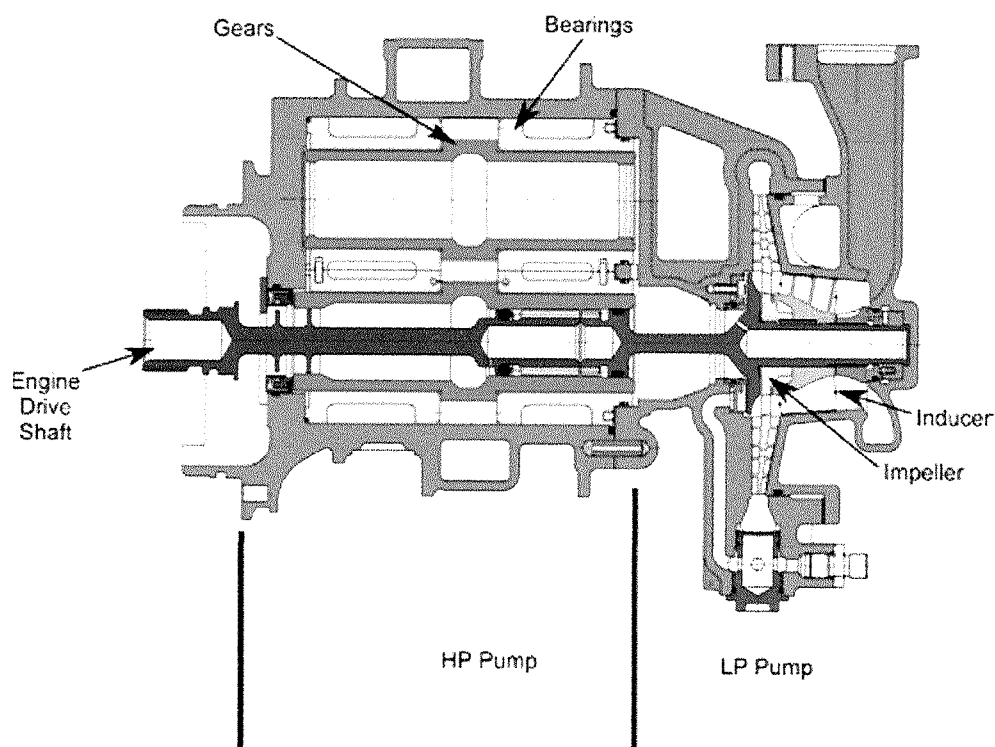
Figure 9

Main Engine Pump (MEP)

Subsequent examination of the right engine HP pump revealed the presence of severe cavitation damage, in a similar location to, but worse than, that found on the HP pumps removed from G-YMMM. Data from the DFDR revealed an increase in the combined scavenge oil temperature and a reduction in the oil pressure following a step climb from flight level FL350 to FL370. The step climb occurred approximately 9.5 hours into the 13.5 hour flight and the fuel flow was increased from about 6,900 pph to around 10,900 pph to accomplish

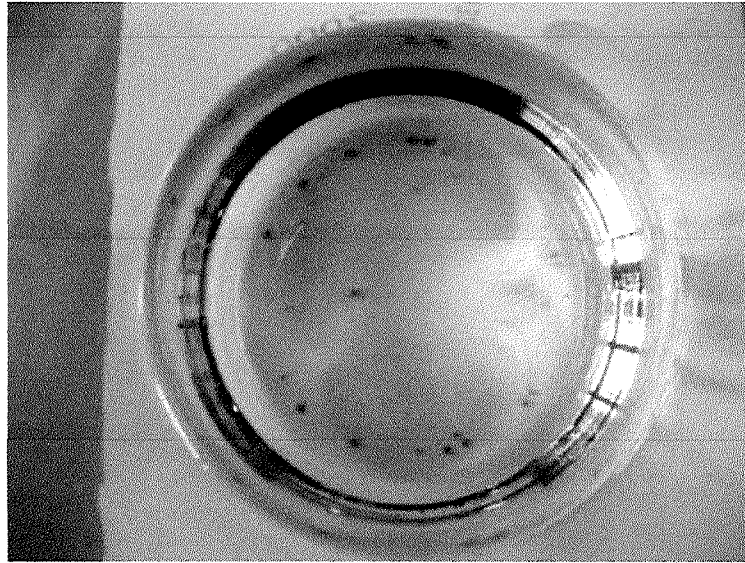
**Figure 59**

Small water droplets were observed in the fuel samples taken from the engine fuel filters and housings. The amount of water was too small to measure and so was classified by reference to the QinetiQ fuel appearance table as being 'small'. Figure 59 is a reconstruction of the QinetiQ description of 'small' using water coloured with food dye.

Reconstruction of a '*small*' amount of dyed water in aviation turbine fuel
